**PENNSYLVANIA
ROSE VALLEY LAKE DAM**

**NDI I.D. No. PA-01127
PENNDER I.D. No. 41-97**

**PHASE I INSPECTION REPORT
NATIONAL DAM INSPECTION PROGRAM**

JULY 1980

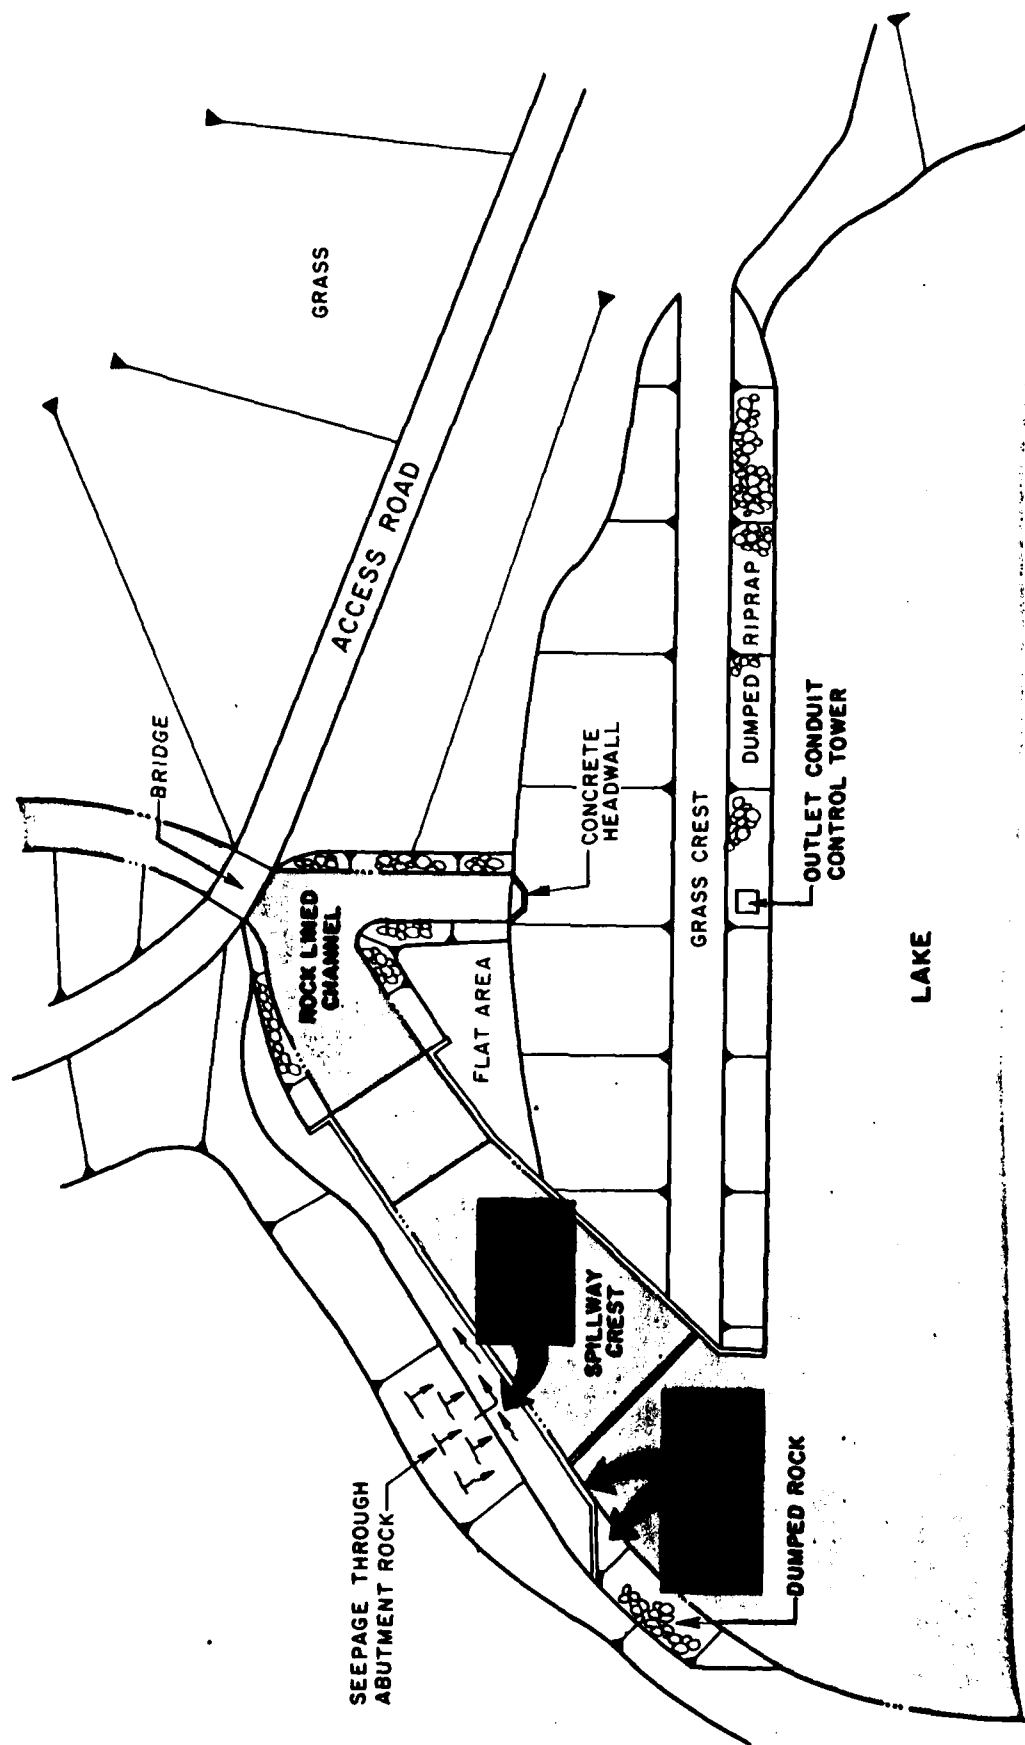
ROSE VALLEY LAKE DAM
GENERAL PLAN - FIELD INSPECTION NOTES

ITEM	OBSERVATIONS/REMARKS/RECOMMENDATIONS	NDI# PA · 01127
SURFACE CRACKS	None observed.	
UNUSUAL MOVEMENT OR CRACKING AT OR BEYOND THE TOE	None observed.	
SLOUGHING OR EROSION OF EMBANKMENT AND ABUTMENT SLOPES	None observed.	
VERTICAL AND HORIZONTAL ALIGNMENT OF THE CREST	Horizontal - good. Vertical - good.	
RIPRAP FAILURES	Limestone and sandstone riprap protects the entire upstream embankment face. Good condition.	
JUNCTION OF EMBANKMENT AND ABUTMENT, SPILLWAY AND DAM	Good condition. Seepage observed through left abutment rock (estimated \approx 2-3 gpm). Water collects between left spillway wingwall and abutment due to poor drainage.
